1. CASE NO. 941115CCC3078 H94A0250		2. INVESTIGATOR'S ID [8][3][1][0]		3. OFFICE CODE [8][7][1]		EPIDEMIOLOGIC INVESTIGATION REPORT	
4. DATE OF INCIDENT YR MO DAY [9][4][1][0][2][1]		5. DATE INVESTIGATION INITIATED YR MO DAY [9][5][0][1][0][5]

6. SYNOPSIS OF INCIDENT OR COMPLAINT A residence fire was determined to have been caused by a toaster oven that overheated. Examination by an electrical engineer found that a part of the oven failed allowing the oven to continue heating. Noone was injured.							
LOCATION (Home, school, etc.) Home [10]		8. CITY Carlsbad			9. STATE CA		
10A. FIRST PRODUCT Toaster Oven [0][2][1][6]		11A. TRADE/BRAND NAME, MODEL NUMBER, MANUFACTURER & ADDRESS Black and Decker, Towson, MD TROYCO

SUBJECT: Laboratory Examination: Black & Decker Toaster Oven
Insured: La Costa Ownership Corporation
Claim #: CC 4152
Your File Number: 1094.27

The failure of the **Black & Decker Toaster Oven Thermostat** caused the unit to continuously heat. No other evidence of electrical malfunction was observed.

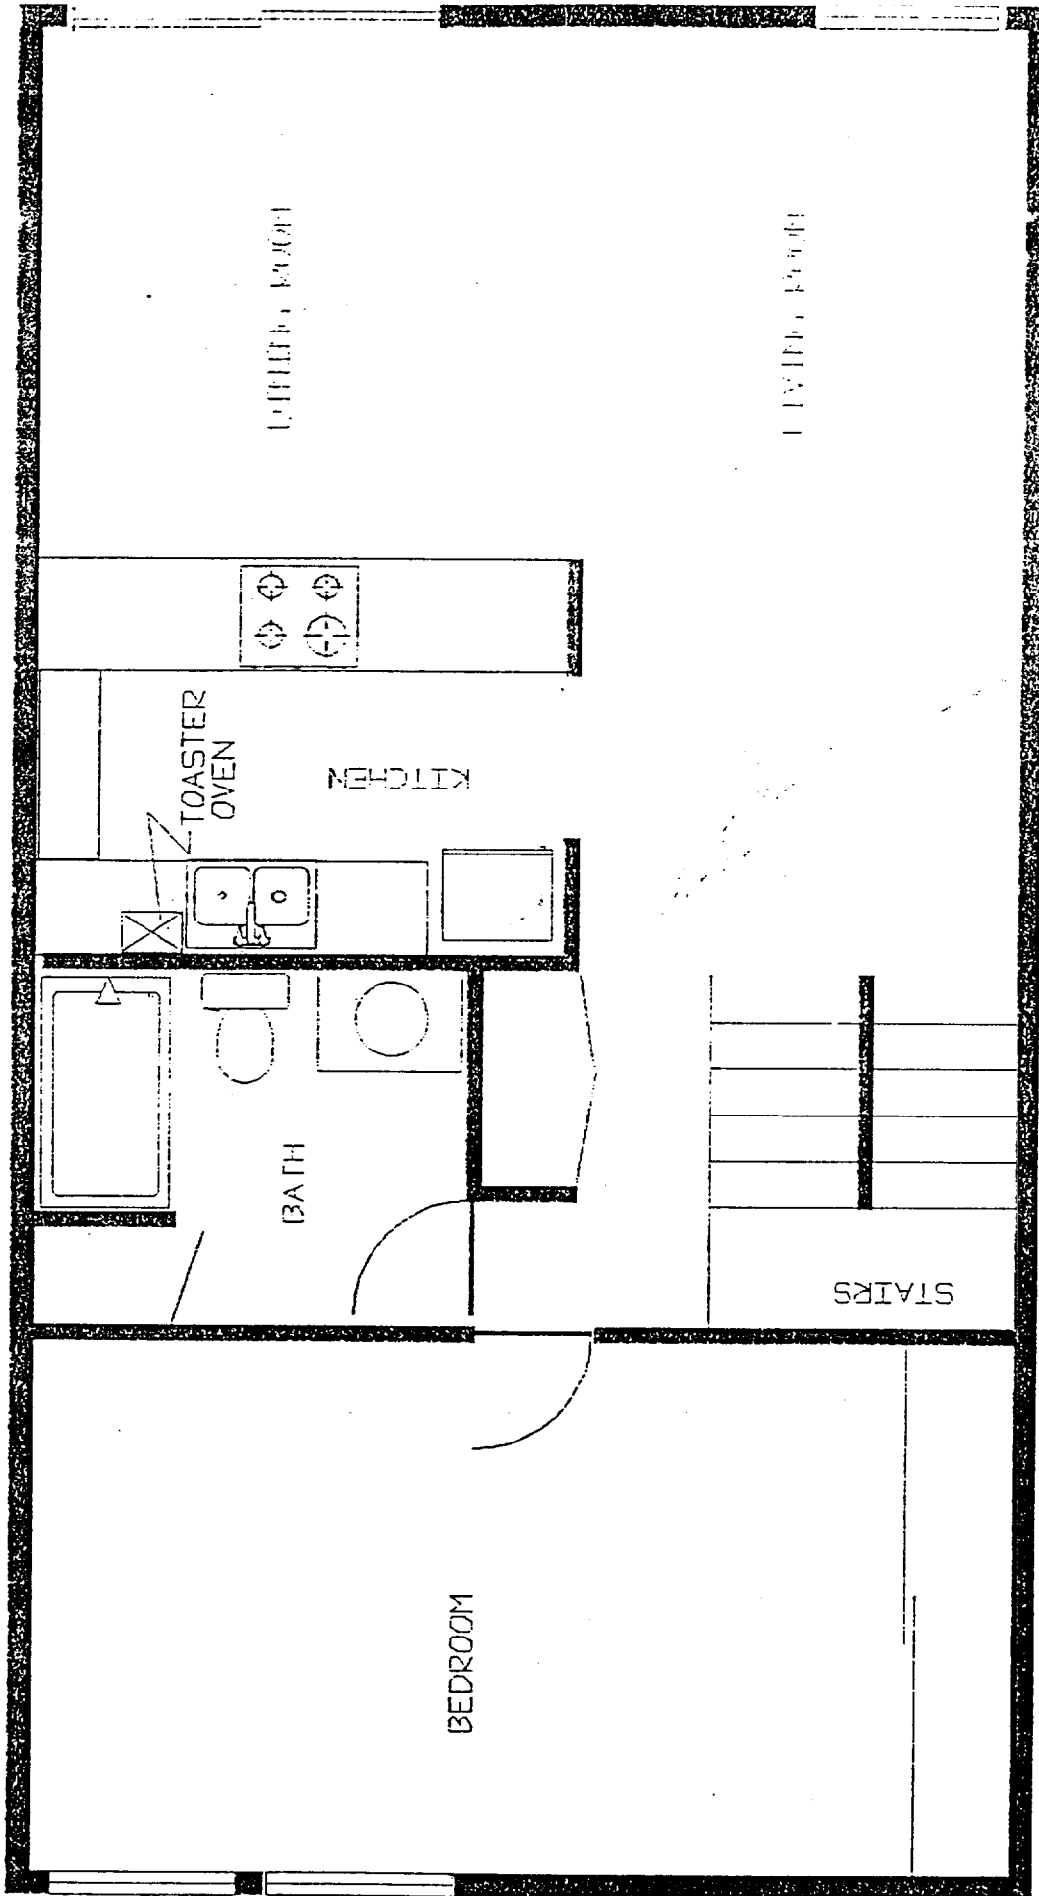
SECOND FLOOR

NOT TO SCALE
BY G. CHURCH
POINT OF ORIGIN
PLANE OF LEAD

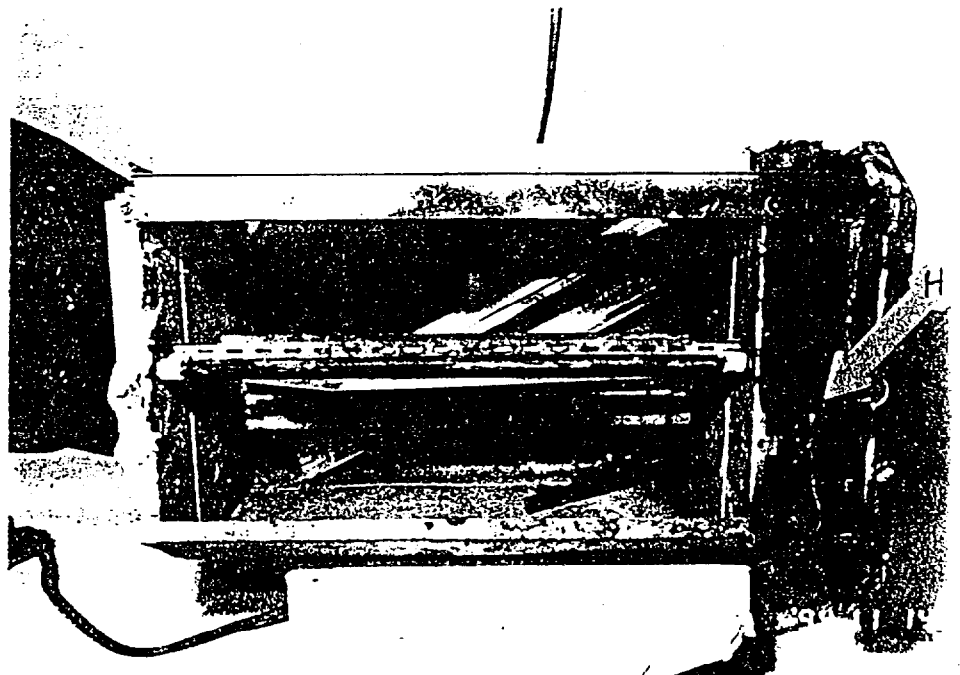
PHOTOGRAPH #3

The **Black & Decker** toaster ovens of this type have a thermostat which fails with the control contacts in the closed position. The oven will then continuously heat until the power supply is interrupted. Several toaster ovens with a similar thermostat have exhibited this problem.

1. It is my opinion based on the post fire condition of the **Black & Decker Toaster Oven** and previous experience with this type of toaster oven that failure of the thermostat (Bake Control) caused the unit to continuously heat resulting in the internal and external damage observed.

The control end of the oven with the plastic end cover removed. Arrow C indicates the thermostat (Bake Control); D, the Pilot Lamp; F, the Toast Control; and H the Door Switch.
